Japan Standard Check

Report ID: PxeQgb2NOpbXL297
Generated: March 2, 2026 15:20:58
Purchased: March 1, 2026 08:52:08

PORSCHE CAYMAN

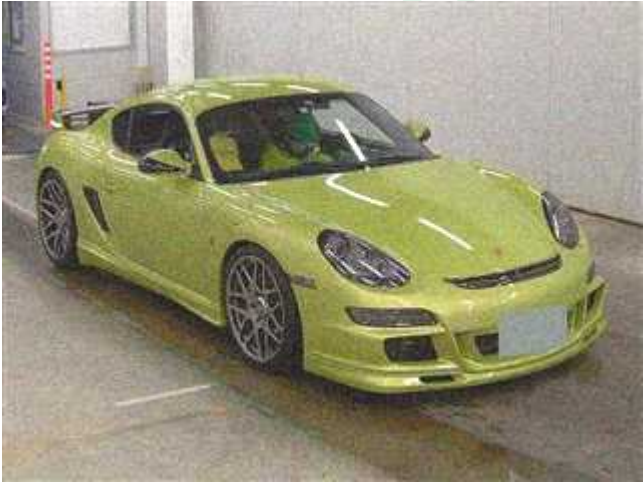
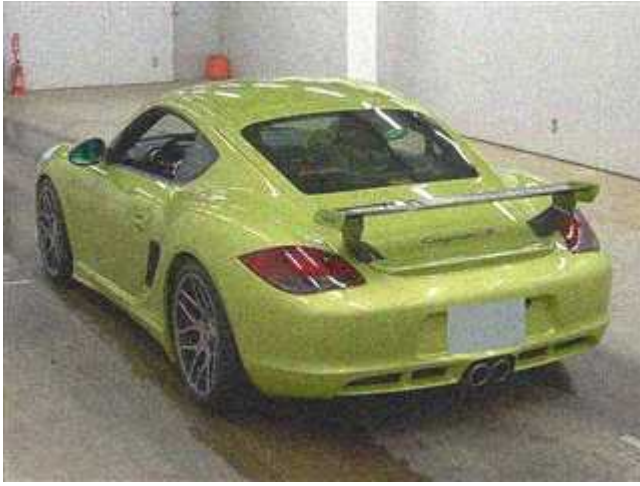
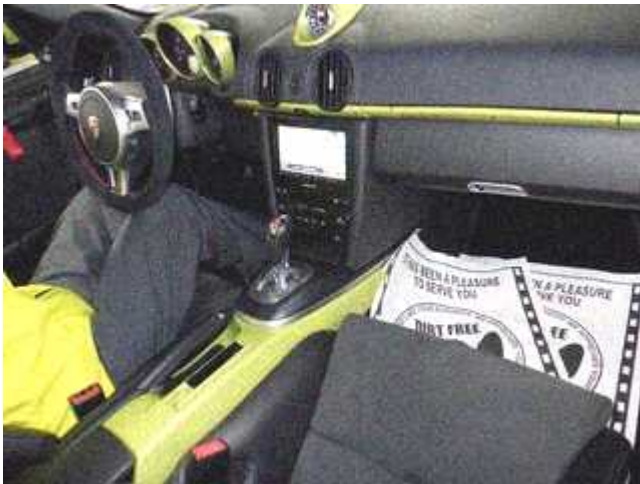
2 / 2 Auction	PORSCHE CAYMAN VIN: WP0ZZZ98ZCS791326 #65191 USS Tokyo 2026-02-26
----------------------------	--

- シートスレ
- ルーム内キズ(多)
- ホイールキズ
- 小キズ凹損傷
